SERVICE BULLETIN VSESB001

SUBJECT: MAIN RISER, LOCKING LOOP WEAR

STATUS: MANDATORY INSPECTION

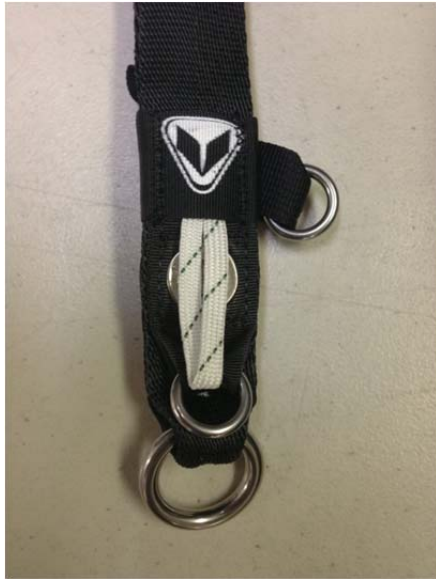
Figure 3: New Locking Loop

The following picture shows a new riser locking loop.

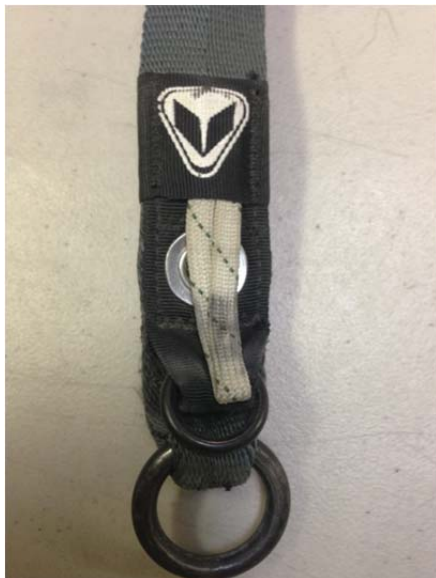
Figure 3: Normal Wear, Front

The following pictures show locking loops with normal wear.

If the loop shows normal wear, the rig can continue to be jumped and no immediate repair is needed.

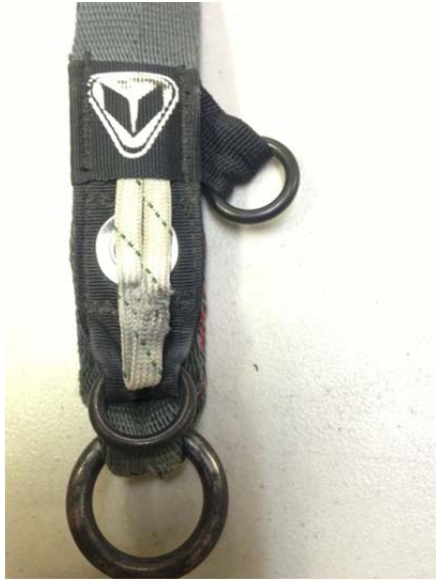
Figure 5: Damaged, Frayed

Several main risers have been found in the field with frayed/partially cut locking loops (the white type 2A loop). The amount and location of damage on the loops varies, leading VSE to conclude there may be several contributing factors.

The following pictures show locking loops with damage; heavily frayed and partially cut.

If the loop shows signs of damage, the rig should not be jumped and VSE should be contacted for further instructions. VSE may also ask for additional information to help determine the root cause and most effective repair. At minimum, VSE will need 2-4 photos, one of each riser loop and one of each housing grommet. Please have these available to send to VSE when you call in. In most cases, once the root cause is determined, VSE will provide a parts kit which can be installed by an FAA certified senior or master parachute rigger or foreign equivalent using the Housing Replacement Procedure provided at the end of this service bulletin. In certain cases, VSE will require the rig be returned to VSE for further inspection and repair.

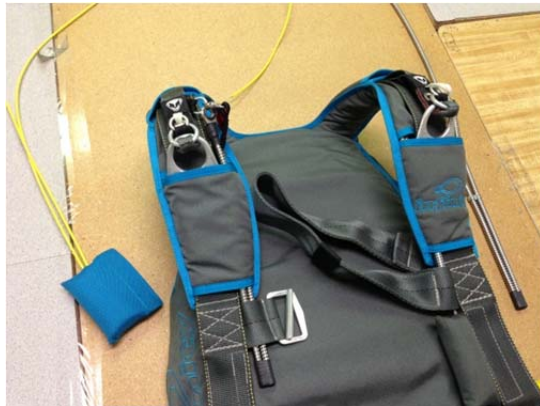
1. Remove the cutaway handle/cables

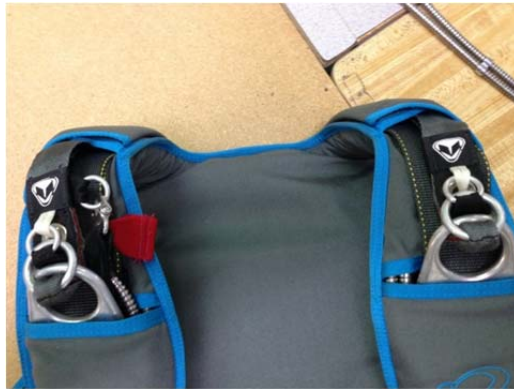
6. Re-assemble the cables and main risers.
